NYC H2O is pleased to submit the attached comments on the NYC Department of Parks & Recreation's Critical Environmental Area proposal. Some main points include:

Worth noting in the Critical Environmental Area application

Corrections and Suggested Additions to Critical Environmental Area Application

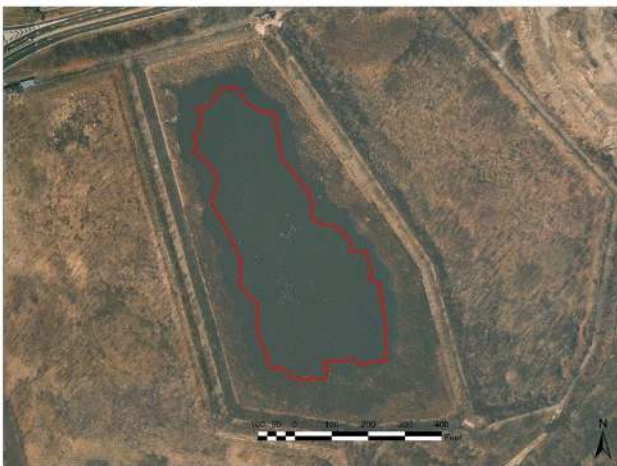
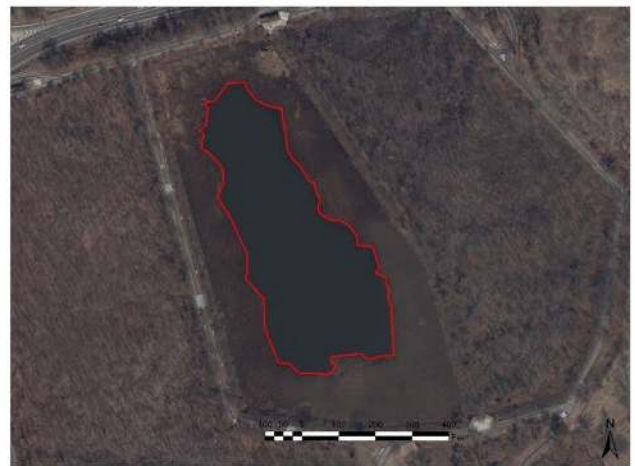
Ridgewood Reservoir 1995, 2014

We submit the following satellite photos from 1995 and 2014 showing the phragmites "choking" the freshwater pond in basin 2 and ask that they be included in the report. Our hope that a plan to mitigate the Phragmites is enacted in short order.

Encroachment of Phragmites ~50ft

1995

2014

The eastern basin consists primarily of native vegetation with a rim of invasive species. The central basin is open water surrounded by invasives, primarily Phragmites.
